New Hampshire Volunteer Lake Assessment Program

2002 Bi-Annual Report for Mountain Lakes Haverhill

NHDES
Water Division
Watershed Management Bureau
6 Hazen Drive
Concord, NH 03301

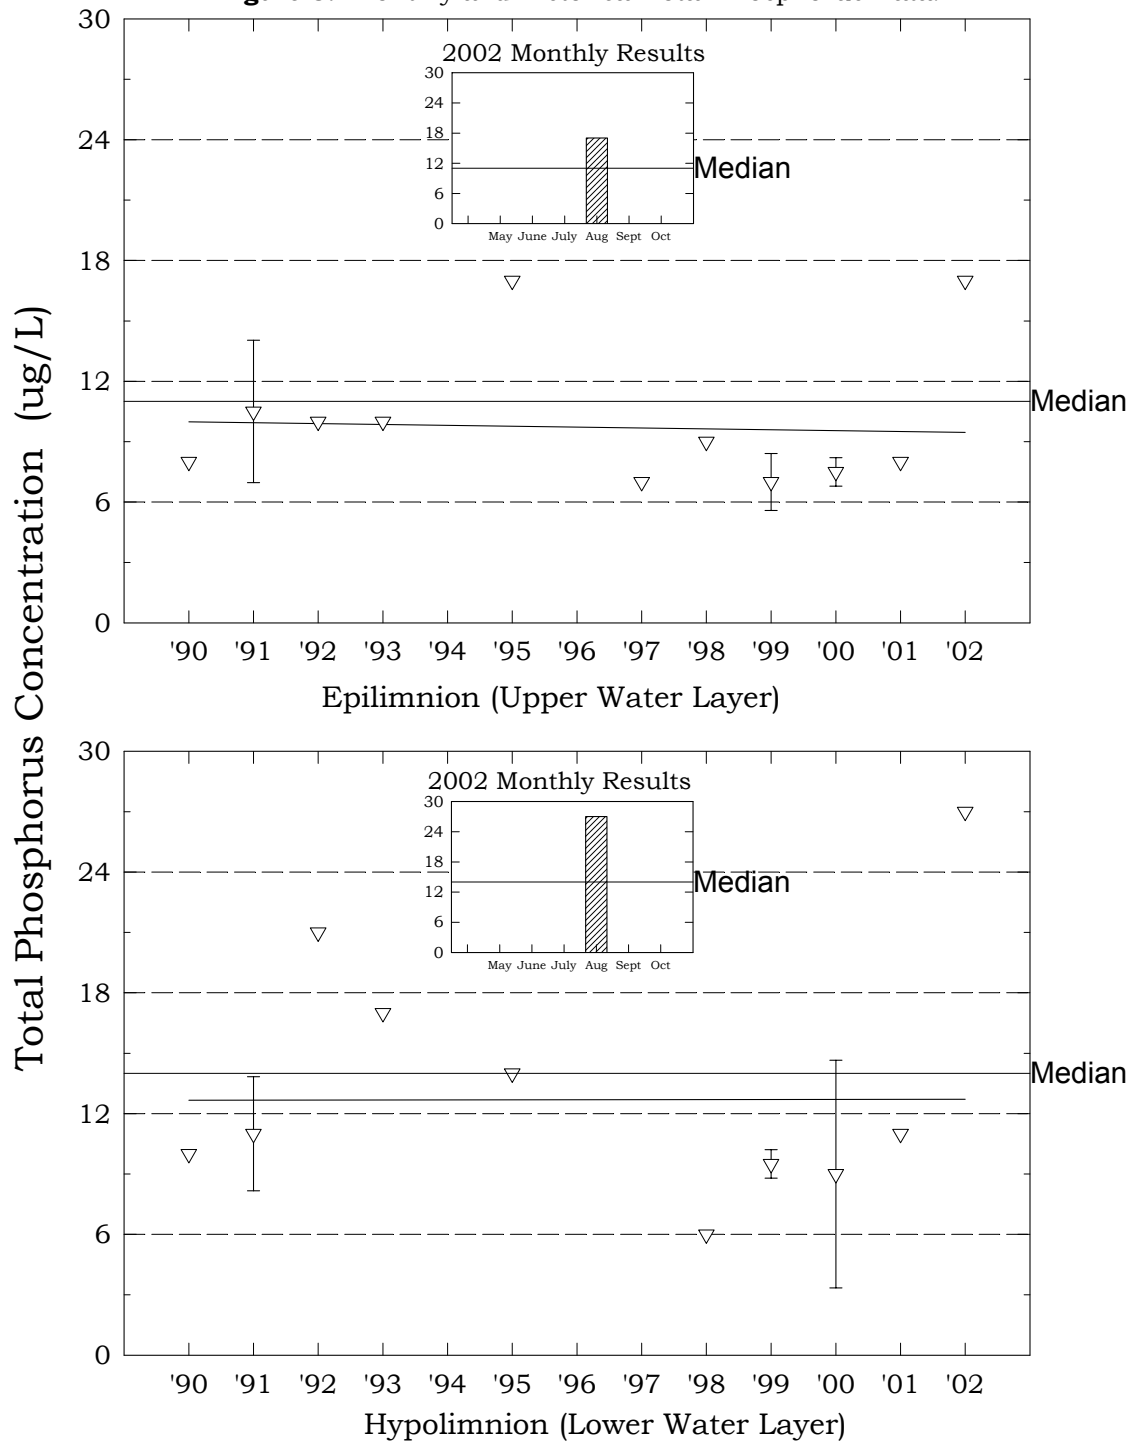
Figure 3. Monthly and Historical Total Phosphorus Data.

The current year data for the epilimnion (the top inset graph) and the hypolimnion (the lower inset graph) show that the total phosphorus concentration in August was ***greater than*** the state median.

However, it is important to note that the turbidity of the hypolimnion (lower layer) sample was elevated (4 NTUs). This suggests that the lake/pond bottom may have been disturbed by the anchor or by the Kemmerer Bottle while sampling. When the lake/pond bottom is disturbed, sediment, which typically contains attached phosphorus, is released into the water column. When collecting the hypolimnion sample, please check to make sure that there is no sediment in the Kemmerer Bottle before filling the sample bottles.

Overall, visual inspection of the historical data for the epilimnion and the hypolimnion show a **variable** total phosphorus trend, which means that the concentration has **fluctuated** since monitoring began.

- **Figure 3 and Table 8:** The graphs in Figure 3 (Appendix A) show the amounts of phosphorus in the epilimnion (the upper layer) and the hypolimnion (the lower layer); the inset graphs show current year data. Table 8 (Appendix B) lists the annual maximum, minimum, and median concentration for each deep spot layer and each tributary since the lake/pond has joined the program.
